Cowles Dissolver Fire Involving IR Flare Mix

Thiokol Corporation

Abstract

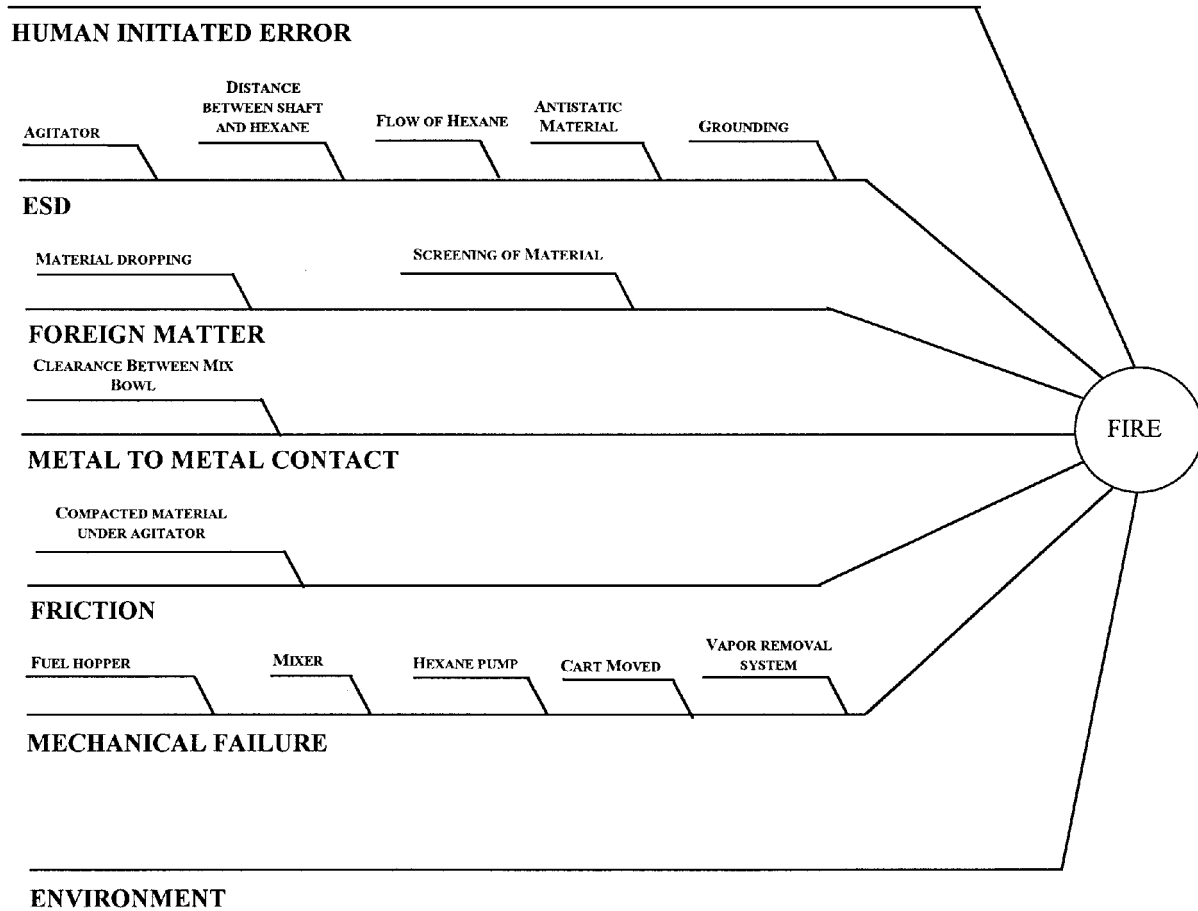
Figure 2. Fault Tree Diagram

Fault Tree Analysis for 54H Incident

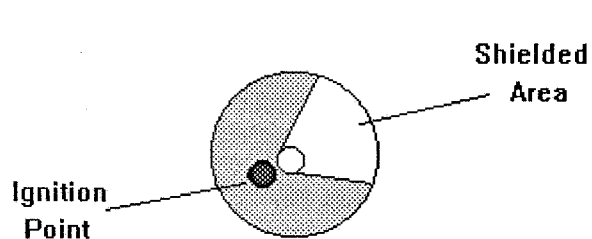
From the tape, the ignition occurring on the front side of the bowl would have allowed the shaft to shield the back side of the bowl from the pressure wave and generated an unbalanced force on the mix. This unbalanced force would have forced the mix down and out the back of the bowl and into the back side of the bay. Examination of the heavy ash deposits in the back of Bay R-110 suggests that this did occur. In this scenario, the hexane ignition alone would have been sufficient to blow the panels off the outside wall and the mix would have ignited as the hexane vapors were driven off of the mix as it splattered throughout the back of the bay. The main fireball from the flare composition would have been reduced somewhat by the action of the deluge water absorbing some of the heat. The video tape frames after the ignition also support continued burning within the bay for a significant time after the main fireball from the mixer bowl.

These conclusions do not alter the recommended actions to improve the handling and safety of the mix.
